# HAYWARD®

## Technical Updates for Pool Professionals

*July/2020*

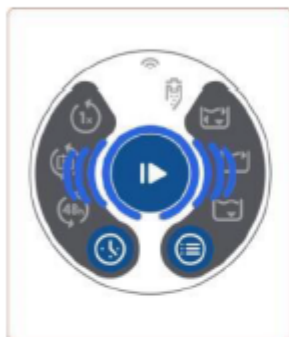
### Lights on PS: Fast flashing blue light

(1<sup>st</sup> time AC Power Up)

Flashing Blue LED

- The Power Supply can't detect or communicate with the cleaner
- Causes
  - Floating cable not properly connected to Power Supply
  - Floating cable connection issue with motor box
  - Floating cable is damaged (loss of conductivity)
- Solutions
  - Disconnect and reconnect floating cable to Power Supply
  - Press Pause/Play Button
  - Try to Power Cycle the Power Supply
  - Try to perform a full reset of Power Supply
  - Clean male and female connector pins if corrosion is observed (Use electrical connector cleaner)
  - Floating cable needs to be serviced
  - Motor Box needs to be serviced

Add to the Solution:

- check for pin alignment or damage on cable connection to power supply connector
- check to see if the female "pins" on power supply connector are stretched.

The female crimp connectors on the power supply could be slightly stretched open and having intermittent contact with the umbilical cable connector pins. In this case, you can take a small flat head screwdriver and very carefully close the gapped connector(s).

For corrosion, a Scotch Brite scouring pad is by far the best thing to use to clean the male pins. The stripped end of a piece of stranded 16-18 gauge wire will work well by spinning it inside of the female connectors on the power supply. Even if you don't see heavy corrosion, start there.

**If these measures do not resolve the issue**, try a different power supply if one is available. If that doesn't resolve it replace the entire cleaner and return the original to Clemmons for evaluation.

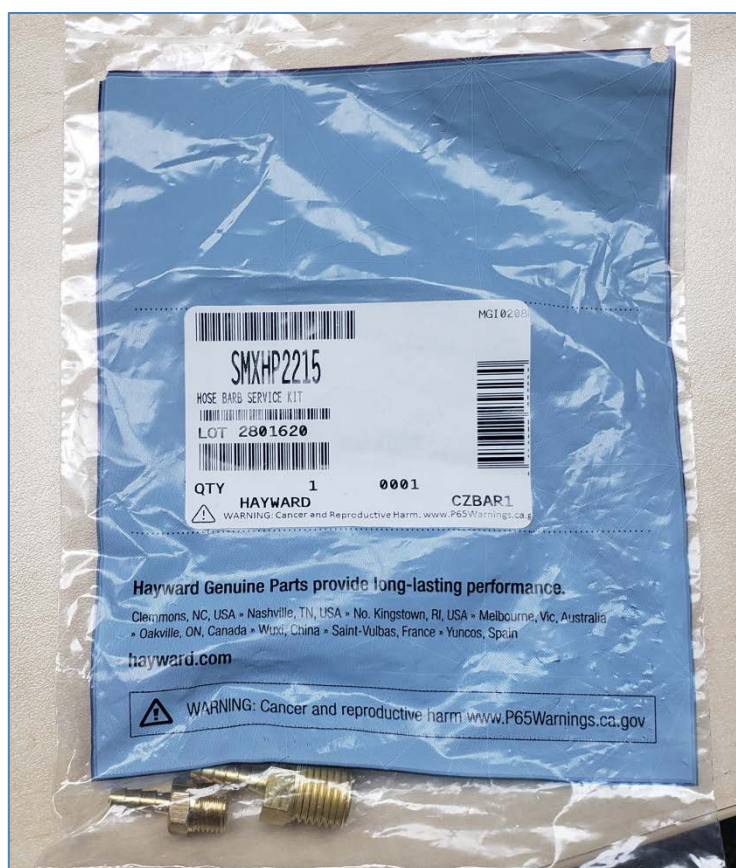
All Nashville built heat pumps beginning with serial # 21131907104876001 / model # HP21104T now have a ¼" NPT X 1/8" barbed fitting for the water pressure connection.

- The spare part SMXHP2215 that is in place for the previous 1/8" NPT X 1/8" barbed has been updated to include both fittings.

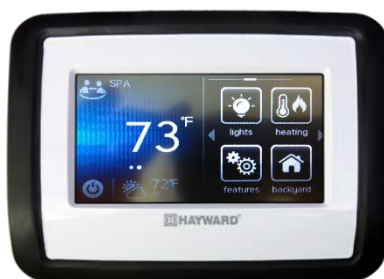
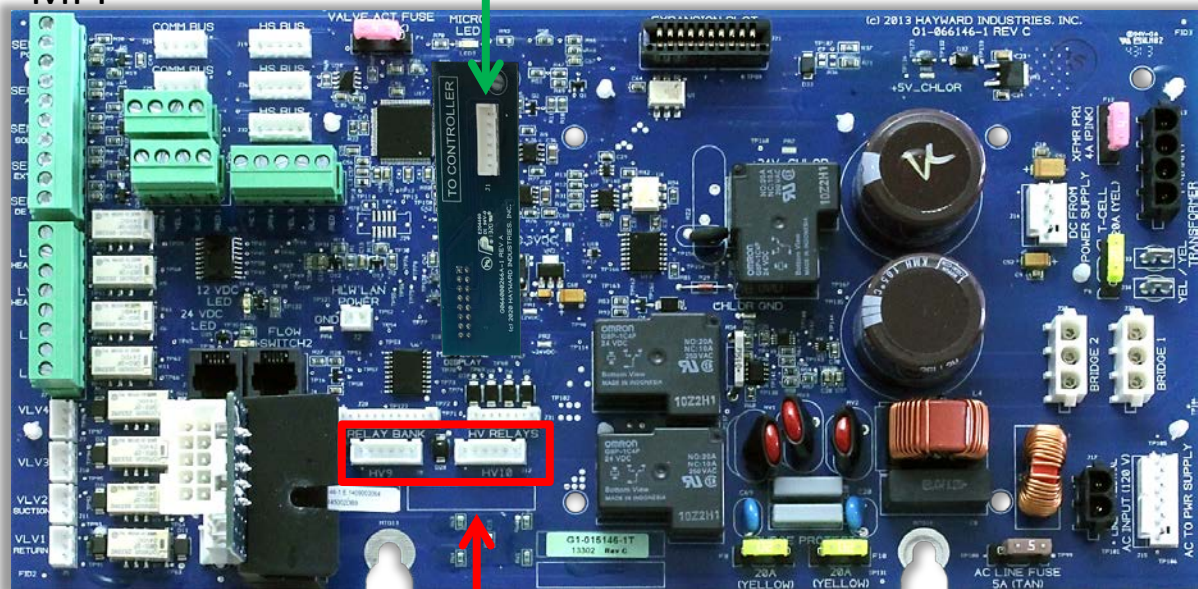
There has been a couple of instances where someone has incorrectly wired an OmniPL controller to one of the high voltage relay(HVR) connectors on the MPP. This caused the controller to be damaged beyond repair.

Do not connect the controller to a HVR port

- Wiring the OmniPL controller to a HVR connector will **damage** it.
- The OmniPL should **always** be wired to the controller port.
